# New Hampshire Volunteer Lake Assessment Program

## 2002 Interim Report for Stone Pond Marlborough

NHDES Water Division Watershed Management Bureau 6 Hazen Drive Concord, NH 03301

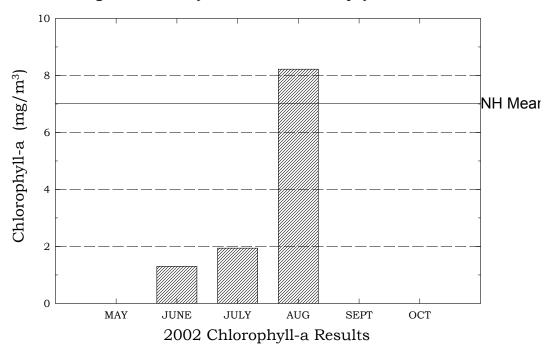
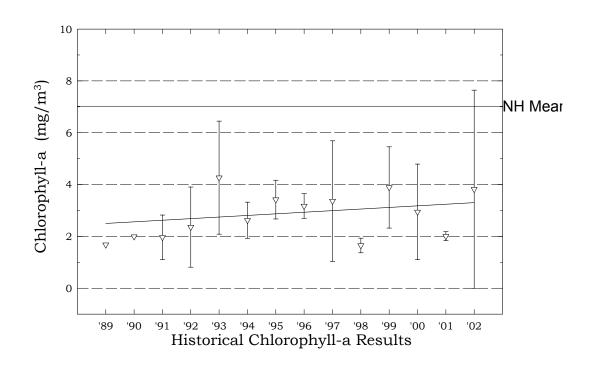
Figure 1. Monthly and Historical Chlorophyll-a Results

Figure 1 and Table 1: The graphs in Figure 1 (Appendix A) show the historical and current year chlorophyll-a concentration in the water column. Table 1 (Appendix B) lists the maximum, minimum, and mean concentration for each sampling season that the lake/pond has been monitored through the program.

The current year data show that the chlorophyll-a concentration in August was *elevated* and *slightly greater than* the state median. However, the elevated chlorophyll did not appear to affect the clarity in the pond.

The historical data (the bottom graph) show that the 2002 chlorophyll-a mean was **less than** the state mean. Overall, visual inspection of the historical data trend line (the bottom graph) shows **a** variable, but overall increasing (meaning worsening), in-lake chlorophyll-a trend since monitoring began in 1989.

While algae are naturally present in all lakes/ponds, an excessive or increasing amount of any type is not welcomed. In freshwater lakes/ponds, phosphorus is the nutrient that algae depend upon for growth. Therefore, algal concentrations may increase when there is an increase in nonpoint sources of nutrient loading from the watershed, or in-lake sources of phosphorus loading (such as phosphorus releases from the sediments). It is important to continually educate residents about how activities within the watershed can affect phosphorus loading and lake quality.

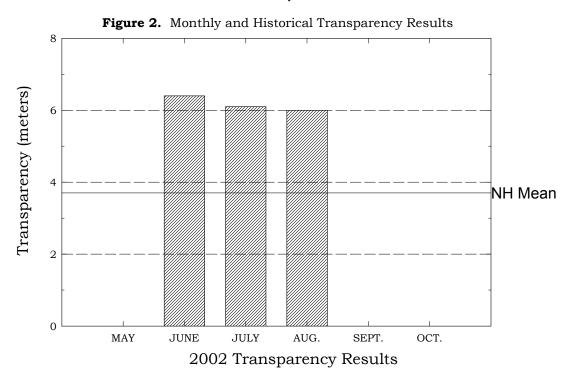
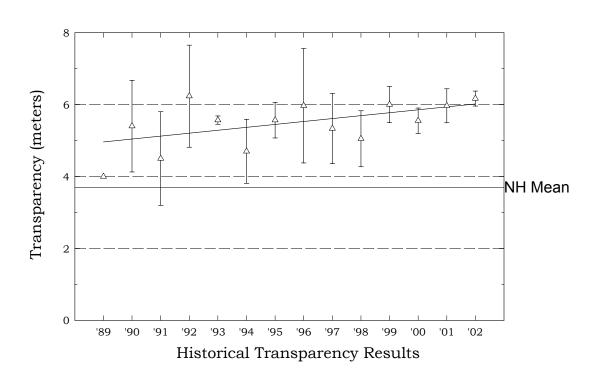
Figure 2 and Table 3: The graphs in Figure 2 (Appendix A) show historical and current year data for lake/pond transparency. Table 3 lists the maximum, minimum and mean transparency data for each sampling season that the lake/pond has been monitored through the program.

The historical data (the bottom graph) show that the 2002 mean transparency is **approximately 2.5 meters greater than** the state mean. It is worthy to note that the annual mean this season is the second greatest annual mean since monitoring began.

Overall, visual inspection of the historical data trend line (the bottom graph) shows **a slightly increasing (meaning improving)** trend for in-lake transparency.

Typically, high intensity rainfall causes erosion of sediments into the lake/pond and streams, thus decreasing clarity. Efforts should continually be made to stabilize stream banks, lake/pond shorelines, disturbed soils within the watershed, and especially dirt roads located immediately adjacent to the edge of tributaries and the lake/pond. Guides to Best Management Practices designed to reduce, and possibly even eliminate, nonpoint source pollutants are available from NHDES upon request.

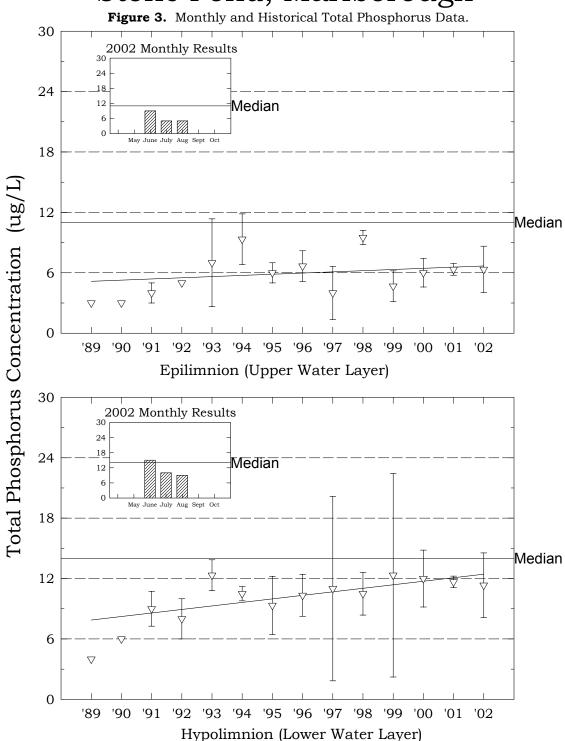
Figure 3 and Table 8: The graphs in Figure 3 (Appendix A) show the amounts of phosphorus in the epilimnion (the upper layer) and the hypolimnion (the lower layer); the inset graphs show current year data. Table 8 (Appendix B) lists the annual maximum, minimum, and median concentration for each deep spot layer and each tributary since the lake/pond has joined the program.

The historical data for the epilimnion (upper layer) show that the 2002 total phosphorus mean is **much less than** the state median.

Overall, visual inspection of the historical data trend line for the epilimnion shows **a stabilizing** trend which is **much less than** the state median. We hope this trend continues!

The historical data for the hypolimnion (lower layer) show that the 2002 total phosphorus mean is **slightly less than** the state median. Overall, visual inspection of the historical data trend line for the hypolimnion shows **a slightly increasing (meaning worsening)** total phosphorus trend since monitoring began.

One of the most important approaches to reducing phosphorus loading to a waterbody is to continually educate watershed residents about its sources and how excessive amounts can adversely impact the ecology and value of lakes and ponds. Phosphorus sources within a lake or pond's watershed typically include septic systems, animal waste, lawn fertilizer, road and construction erosion, and natural wetlands. If you would like to educate watershed residents about how they can help to reduce phosphorus loading into the lake/pond, please contact the VLAP Coordinator.
